## GLAZER'S REAL ESTATE, LLC HOUSTON, TX

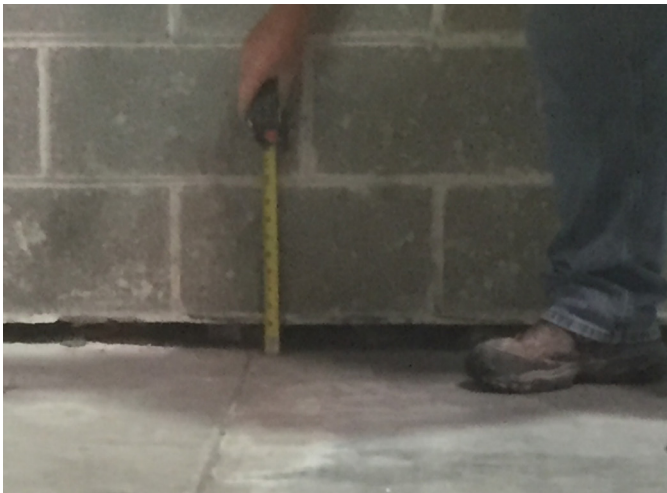
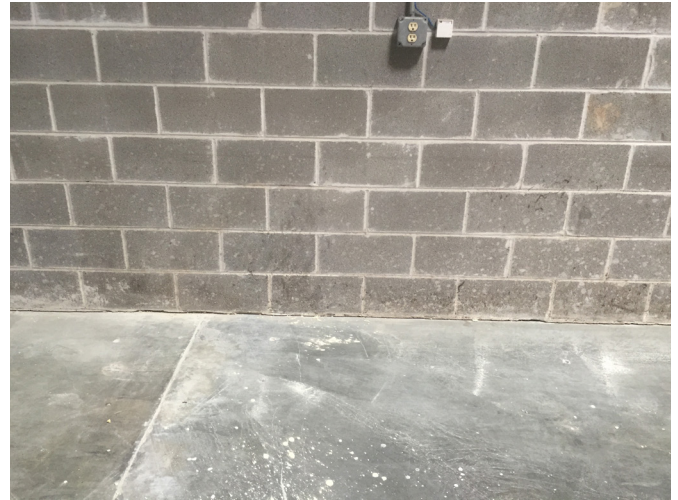
Distribution center – Massive tilt wall building with steel racks from floor to ceiling throughout the facility where Glazers spirits are stored prior to delivery. The steel storage racks on the perimeter of the North and West walls were leaning to the extent it became a critical safety issue. The pour strip had begun settling quickly from 3 to 8 FT out from the perimeter wall. Warehouse space was a premium, and they had already begun moving product off the racks because of the safety concerns, affecting the forklift traffic flow of the operation. Minimizing downtime was extremely important.

Glazer's contacted Superior and requested an effective repair solution that was minimally invasive, very efficient, creating as little downtime as possible and which we could mobilize immediately to perform. The injection of High-Density Polyurethane was recommended. Upon drilling the injection holes, large voids were discovered beneath the pour strip to the extent there was little subgrade supporting the foundation. Superior was contacted late on a Wednesday, did a site visit on Thursday morning, mobilized Friday, worked through the weekend and completed the work early Monday. Glazer's was able to return all their products to the shelves and become fully operational within days.

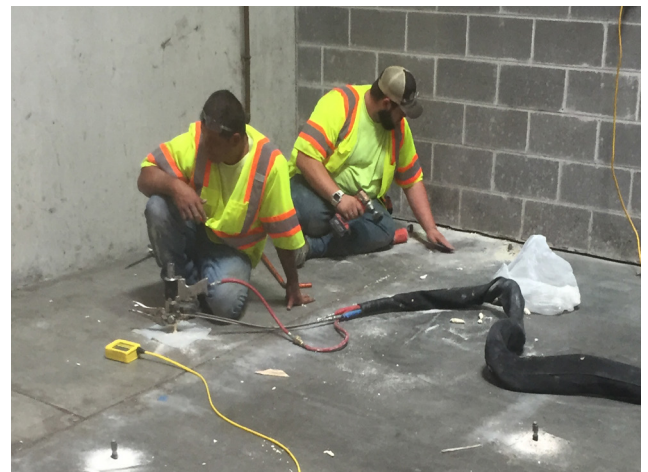
- » The work was performed according to our standard specifications.
- » 8,000 pounds of HD Poly was injected
- » Realigned the pour strip to within the required tolerance
- » Operational downtime was minimized
