VDOT Culvert Rehabilitation, Spring Branch Road

Hampton Roads District, Franklin Residency, Spring Branch Rd (37°02'48.7"N 77°05'40.3"W)
(3ea) 52' of 6' round CMP running under Spring Branch Rd, structural pipe restoration

Project Profile

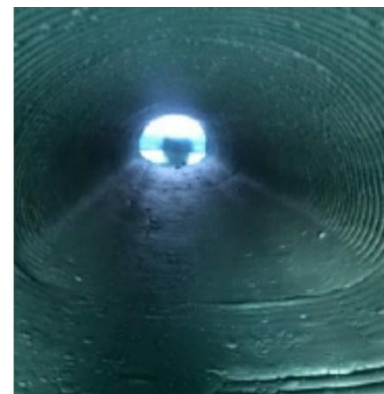
The project involved spraying a structural liner inside of a deteriorated, galvanized corrugated steel culvert. Due to corrosion, the structural bearing capacity of the culvert had been compromised and an engineered solution to carry the load of vehicular traffic was needed.

A solution which did not disrupt traffic and, simultaneously, minimized flow reduction was required. The chosen method of rehabilitation involved utilizing Nukote PP300 and Nukote ST-M to create a structural, composite liner.

Making ready was extensive due to swamp location and rip rap and debris needing to be removed. Host pipe was dewatered and cleaned. Some areas of the invert and walls were missing and required repair/filling. After repairs with foam and concrete were performed, the pipe was cleaned again, dried and the ends of the pipe were primed. The entire pipe was coated lightly with ST-M (~30 mils) using Ringtech 360 system. PP300 (1380mils) was then applied using the Ringtech 360 system. ST-M (120mils) topcoat was then applied with Ringtech 360.
